5.1.1.7 WSZ Targu Ocna

5.1.1.7.1 Water Quantity

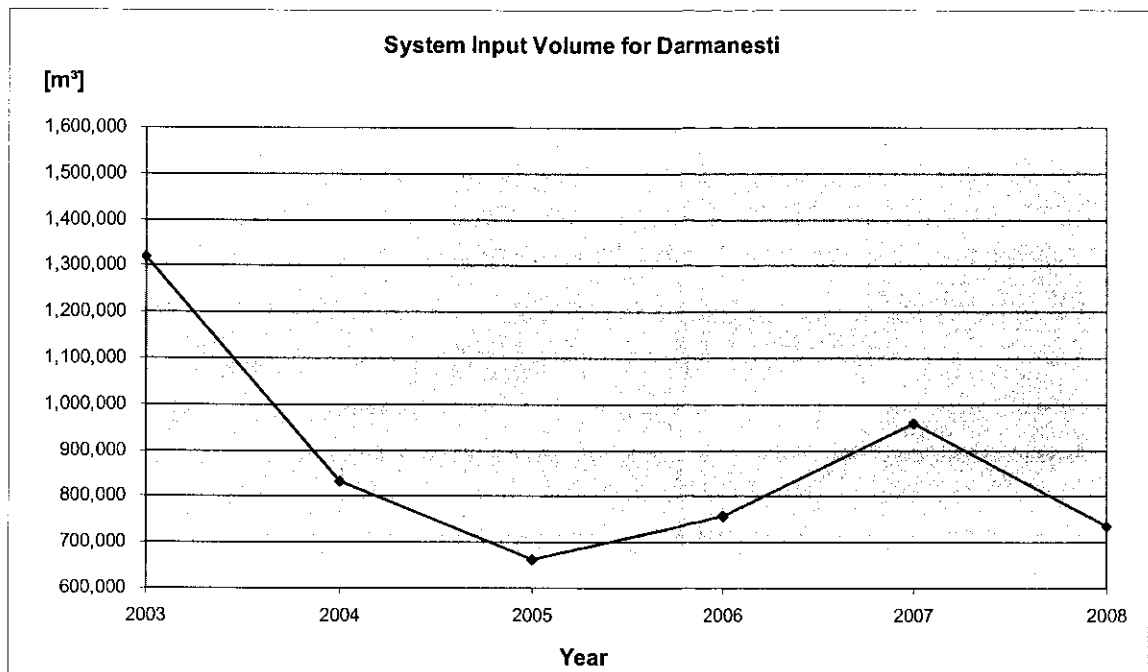
Figure 5-20: System Input Volume from 2003 – 2008 for WSZ Darmanesti

The next figure shows the water production for the years 2003 – 2008.

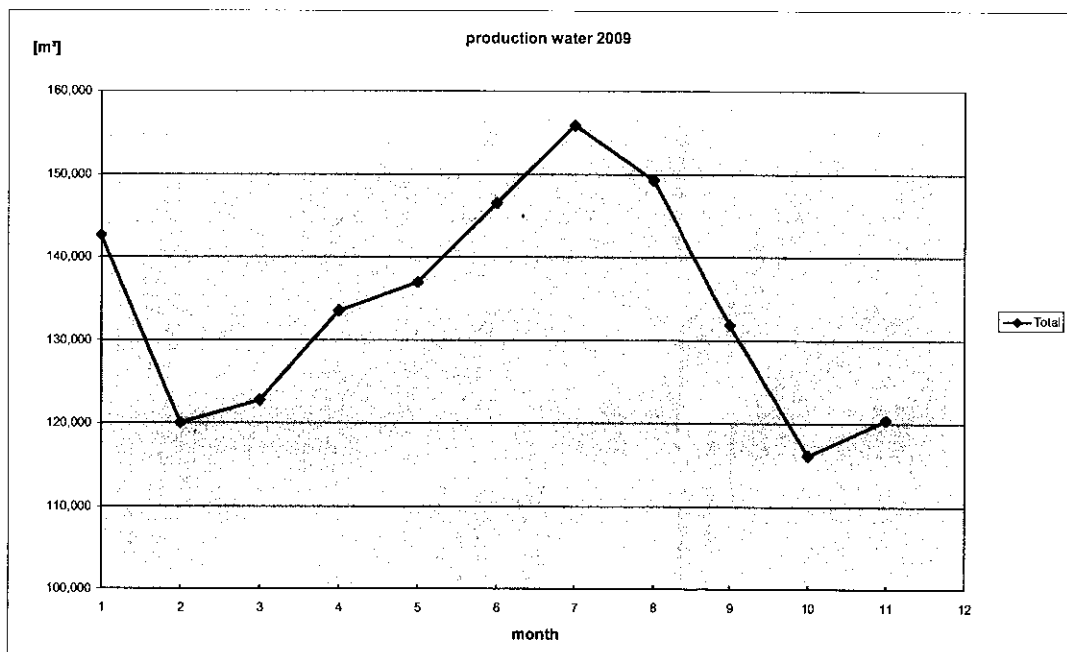
Figure 5-23: Monthly production of water for WSZ Targu Ocna in 2009, except December

A total of 1,475,829 m³ were supplied in 2009 until November 2009, 100 % from the WTP at Darmanesti.

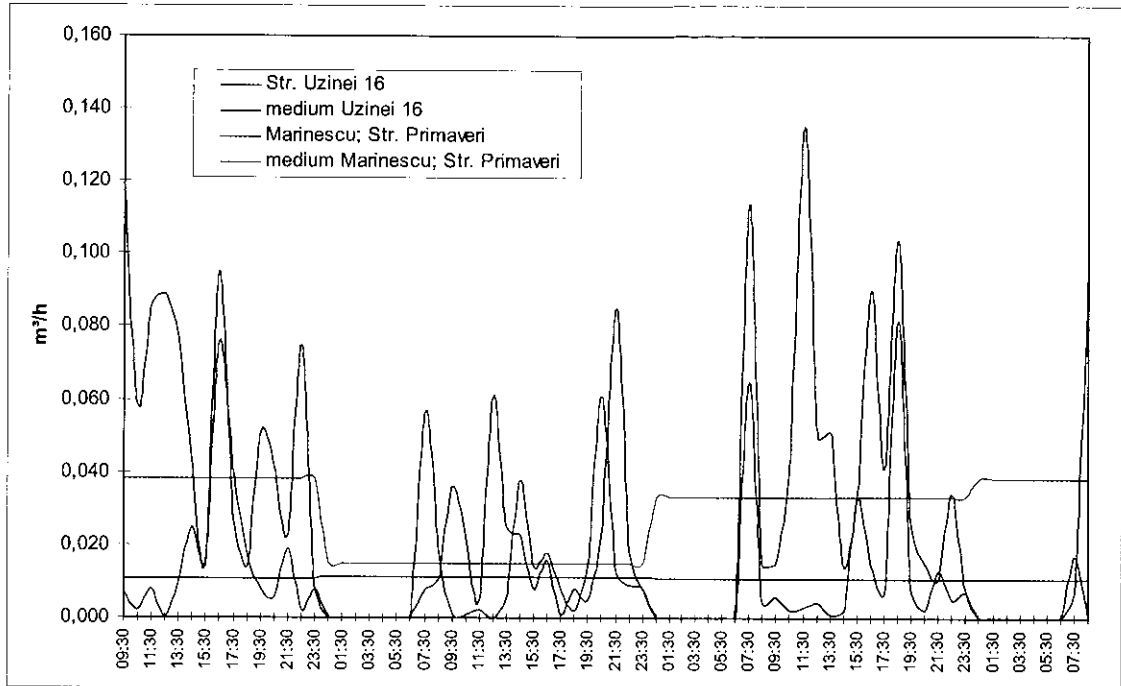
Figure 5-27: Hourly consumption figure of detached houses

As an example, the results of the hourly meterings within the town of Onesti are shown in the following figure.

As already shown in the figure resulting from the meterings of different detached households, two main consumption peaks could be registered. The morning consumption between 7:00 and 9:00 hours and the consumption between 16:00 and 19:00 hours. More than 50% of the total daily consumption was registered in the evening. The maximum daily consumption peak was calculated at 7.5.

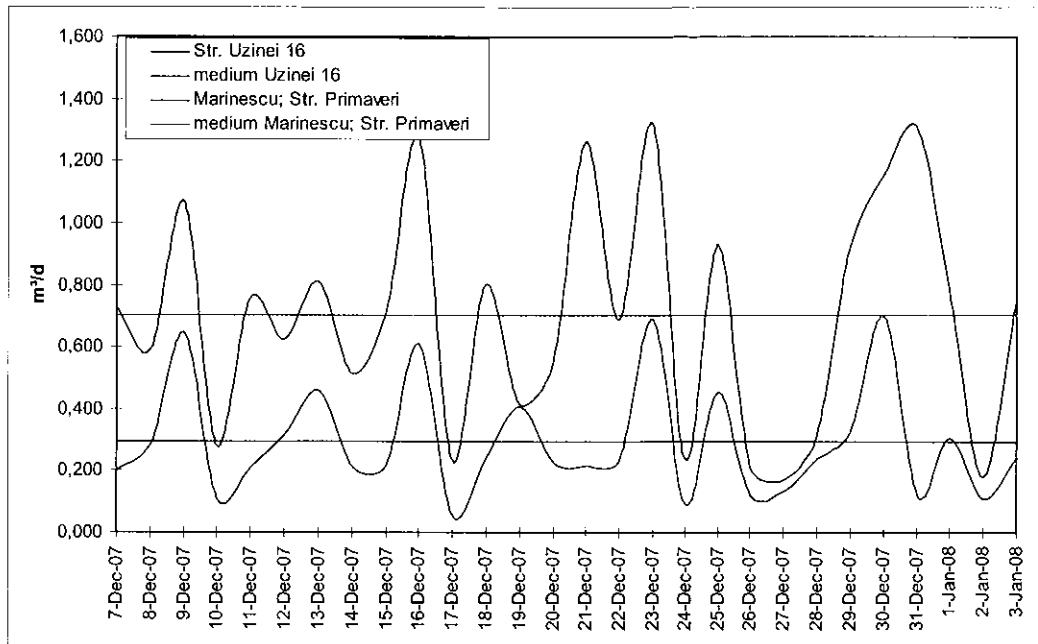
Figure 5-28: Daily consumption figure of detached houses

The daily meterings were performed over a period of more than 2 weeks. Detached houses, block of flats as well as supply pipes to different supply zones were monitored. The examples presented in the next figures show the daily consumption figures of detached houses and blocks of flats within the towns of Onesti and Bacau.

The particularly low values of specific consumptions have not been confirmed by the daily readings for the same households. Specific consumptions have been calculated at 97l/c/day for Uzinei 16 and 175 l/c/day for Primavera.

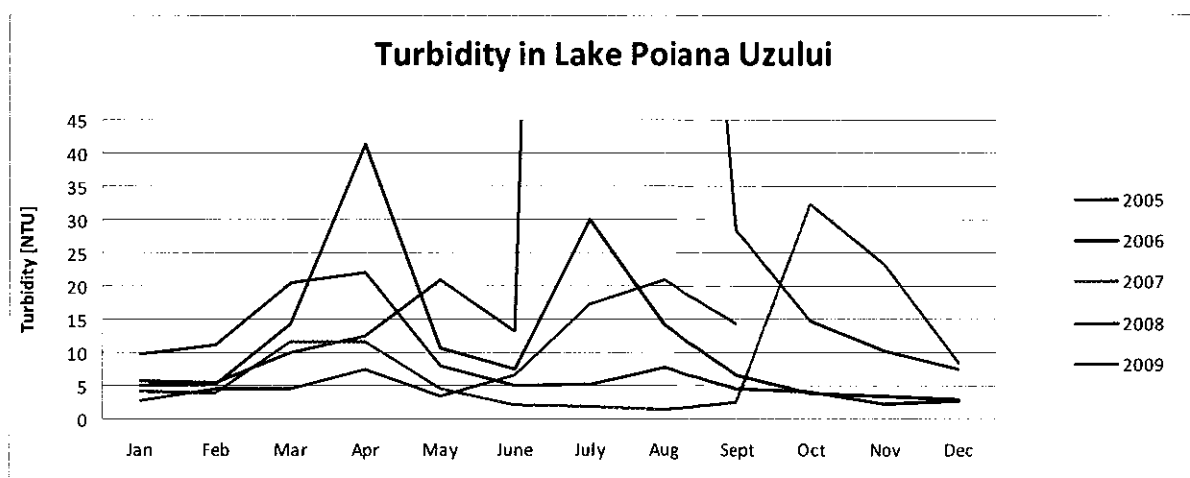
Figure 5-54: Turbidity of raw water from 2005 - 2009 (monthly averages)

As shown in the table above there is a permanent problem of turbidity. This can also be seen in the two figures below.

To show the ranges, the peaks in July 2005 (377 NTU) and August 2005 (152 NTU) are out of scale in Figure 5-54.

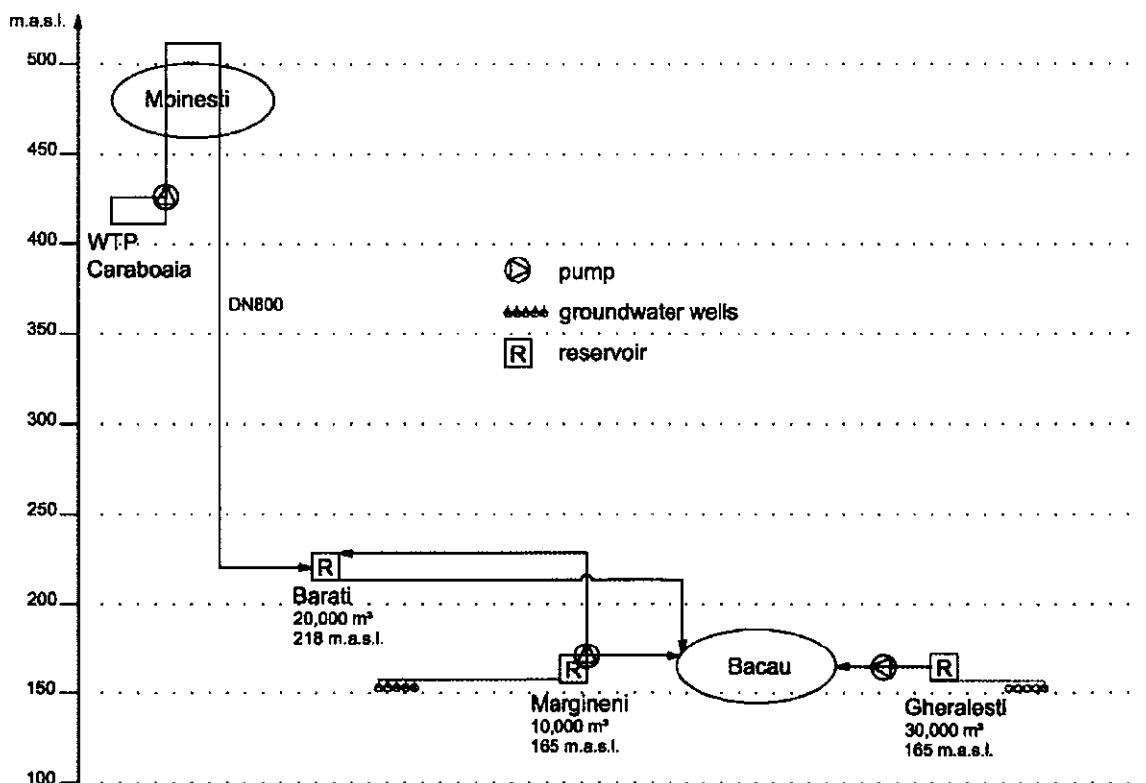
Figure 5-70: Bacau supply system

A general supply scheme of Bacau supply system is shown in the next figure.

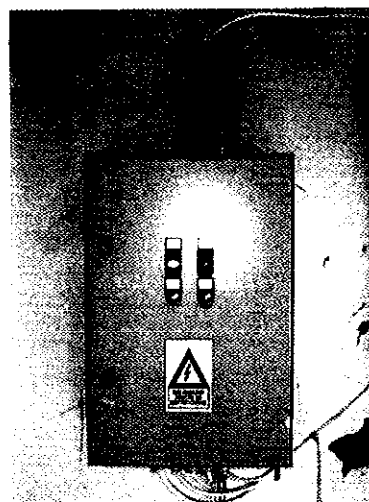
At RSV Micleasca and Cristea the inflow is controlled by automatic valves which are controlled by installed level control sensors. If the RSV is full the valve at the inflow will be closed automatically.

Figure 5-77: Level controller and control of valves at RSV

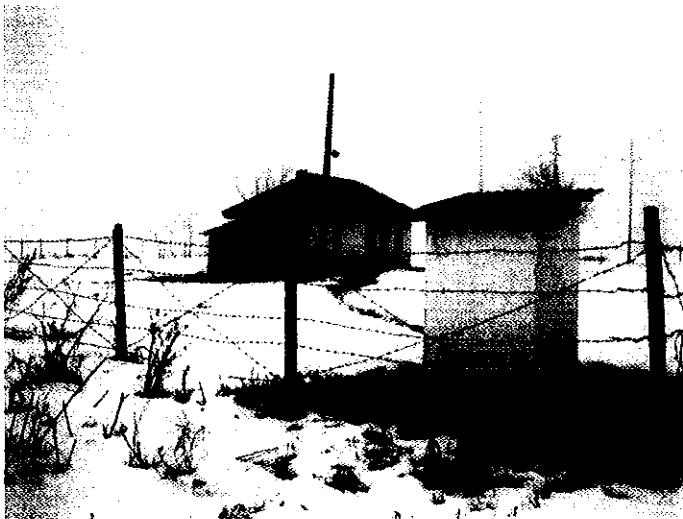
Figure 5-81: Wellfield Poiana Morii

WSZ Buhusi contains only city of Buhusi which is inhabited by approx. 19,644 inhabitants. There are three groundwater sources whereas only source Poiana Morii is usually in operation. The sources Coscau and Bistrita are used additional in peak days when the demand of water is very high.

Well no	Capacity [m ³ /h]	Head [m]	Pump	Power [kW]
1	Not used any more			
2	Not used any more			
3	40	90	Ebara 65/250	22
4	46	87	Grundfos	15
5	46	87	Grundfos	22
6	30	85	Grundfos	9,2
7	30	85	Grundfos	9,2
8	30	85	Grundfos	9,2
9	30	85	Grundfos	9,2
10	30	85	Grundfos	9,5

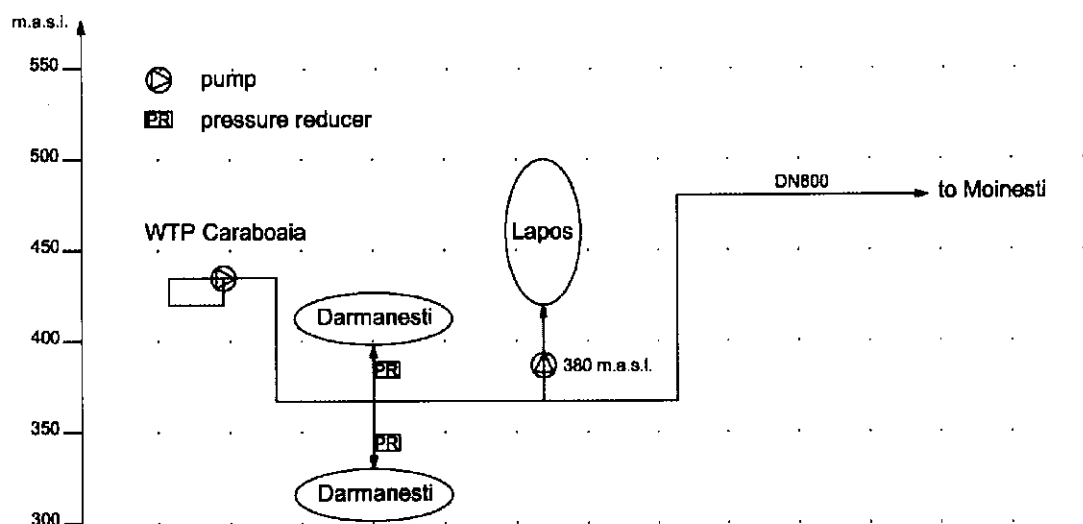
Figure 5-91: Darmanesti supply system

A general supply scheme of Darmanesti supply system is shown in the next figure.

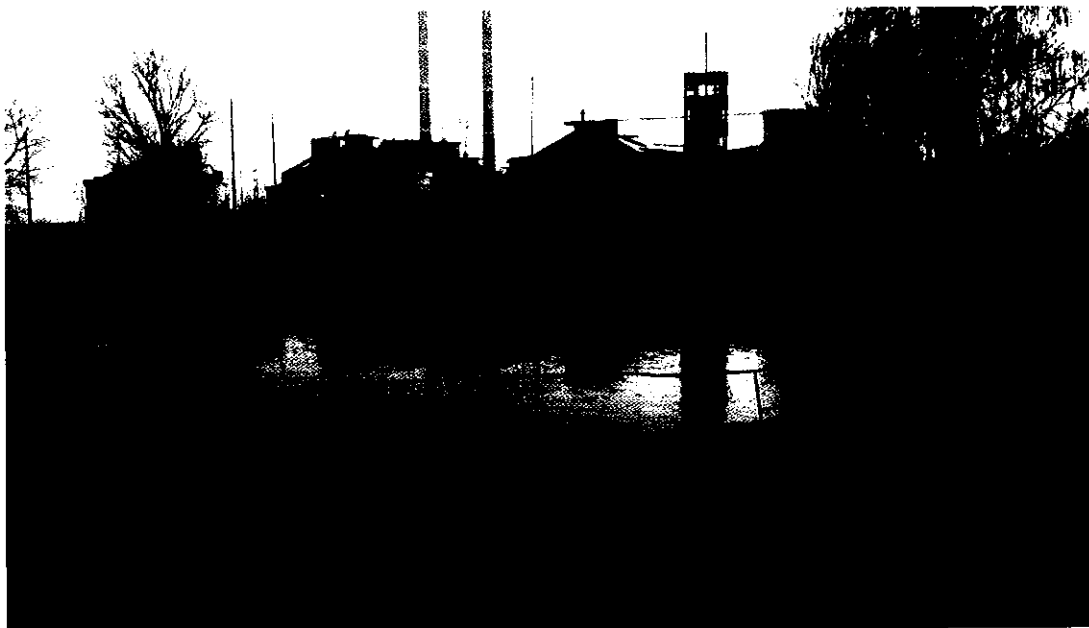
Figure 5-112: WWTP Bacau

Table 5-78: WWTP Bacau – Assessment of physical condition of electro-mechanical equipment and civil structures

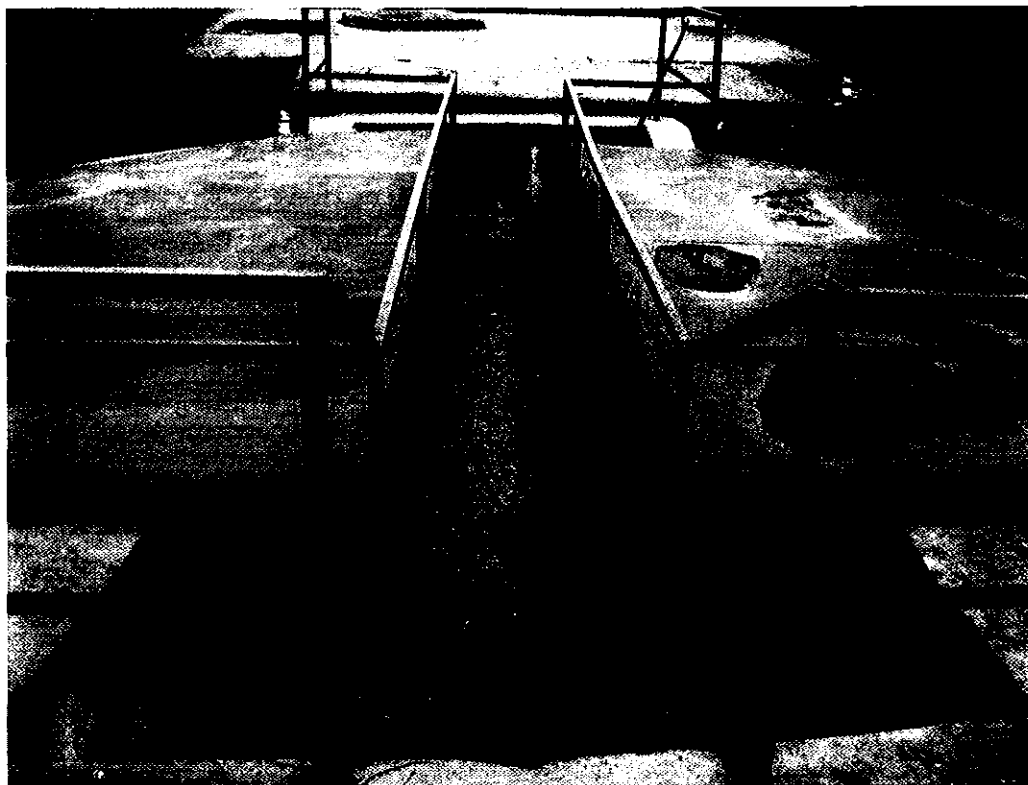
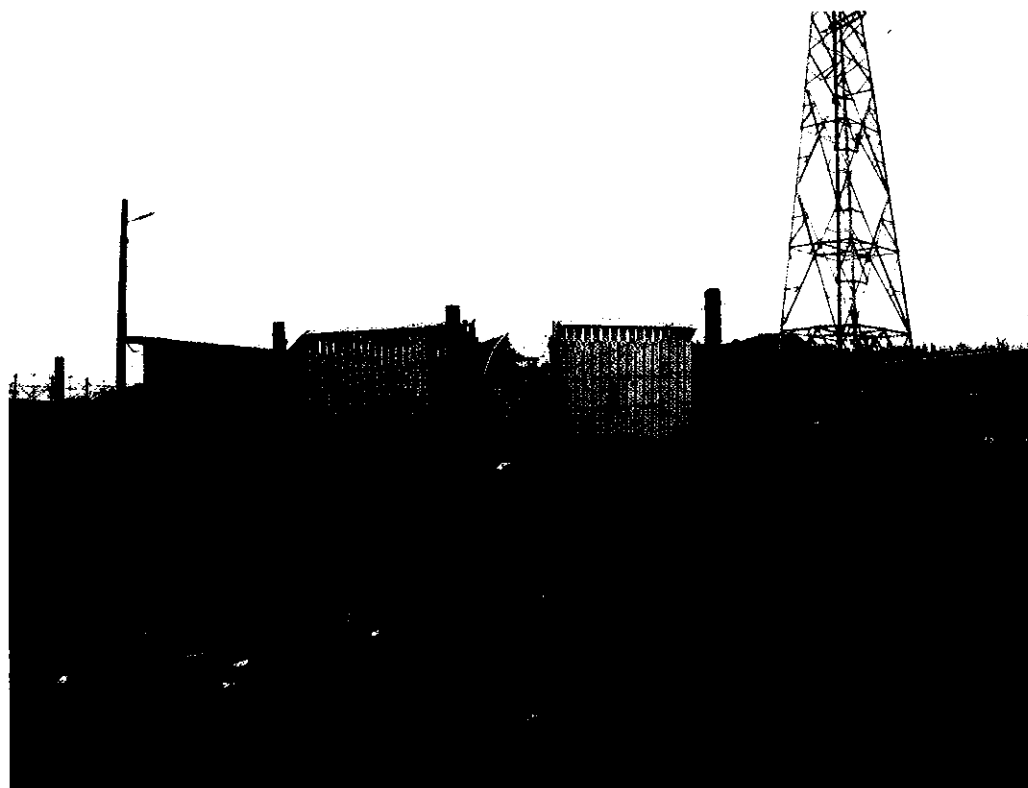
The existing WWTP of Darmanesti is located in the middle of the town and serves a block of flats with high population density. It has only mechanical treatment and is not sufficient for the whole town. Because of the size and the location of the WWTP, it is recommended to dismantle the old WWTP and build a new central WWTP in the south eastern part of Darmanesti where a site in public ownership is available.
